# Birling Gap 4dSU02- Cliff Survey Report 2015 to 2018

## 1.0 Introduction:

This report covers a brief overview of cliff erosion and accretion rates of the Birling Gap frontage. This area covers survey unit 4dSU02 as part of the frontages managed by Adur and Worthing Councils, as part of the Southeast Regional Coastal Monitoring Programme. The data used for this report is derived from surveys completed on the 5<sup>th</sup> of August 2015 and the 14<sup>th</sup> of August 2018.

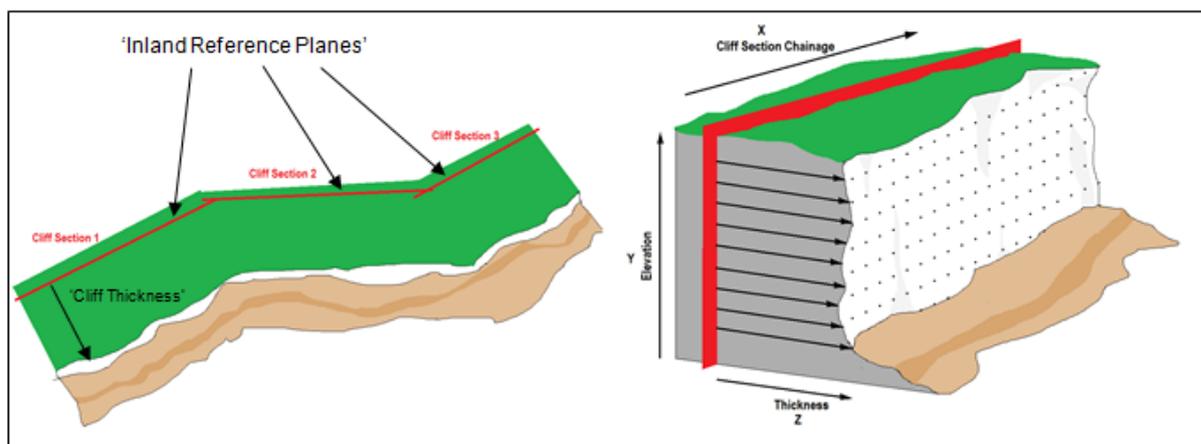
Figure 1- Inland Reference Planes and the concept of 'cliff thickness'

Modelling of the point-cloud is achieved using inland reference planes. Inland Reference Planes have been selected simply as vertical planes that run parallel to the approximate line of the cliff face to provide a consistent comparison. This introduces the concept of 'cliff thickness', which is simply the orthogonal distance from the reference plane to the cliff face (Figure 1). As such, changes in cliff thickness are what are represented in the difference modelling with this methodology. The survey units are divided into sections which outline various areas, each with its own difference model. Each model shows erosion and accretion rates as colour shading, with the deepest colours showing the greater rate of change.

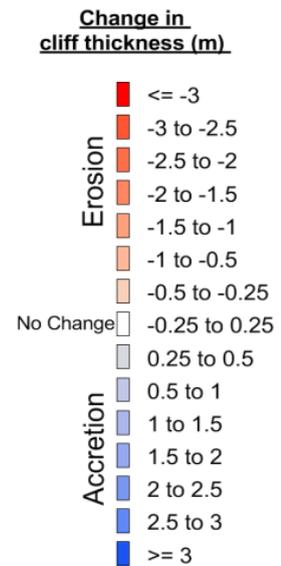
Figure 2- Difference model legend showing Change in Cliff Thickness (m)

The difference model values are split into differing coloured section depending on the rate of erosion or accretion, shown in Figure 2.

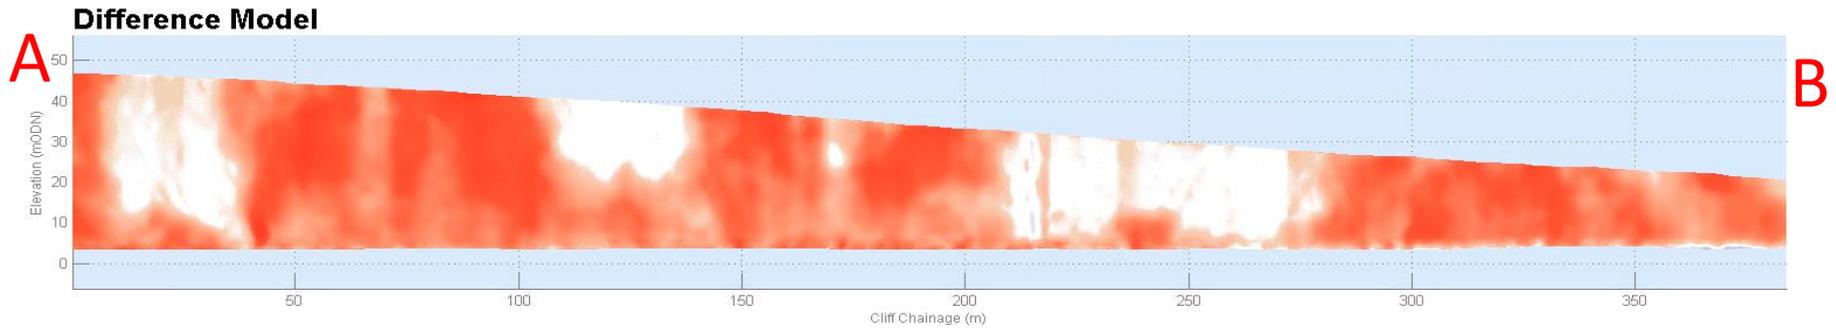
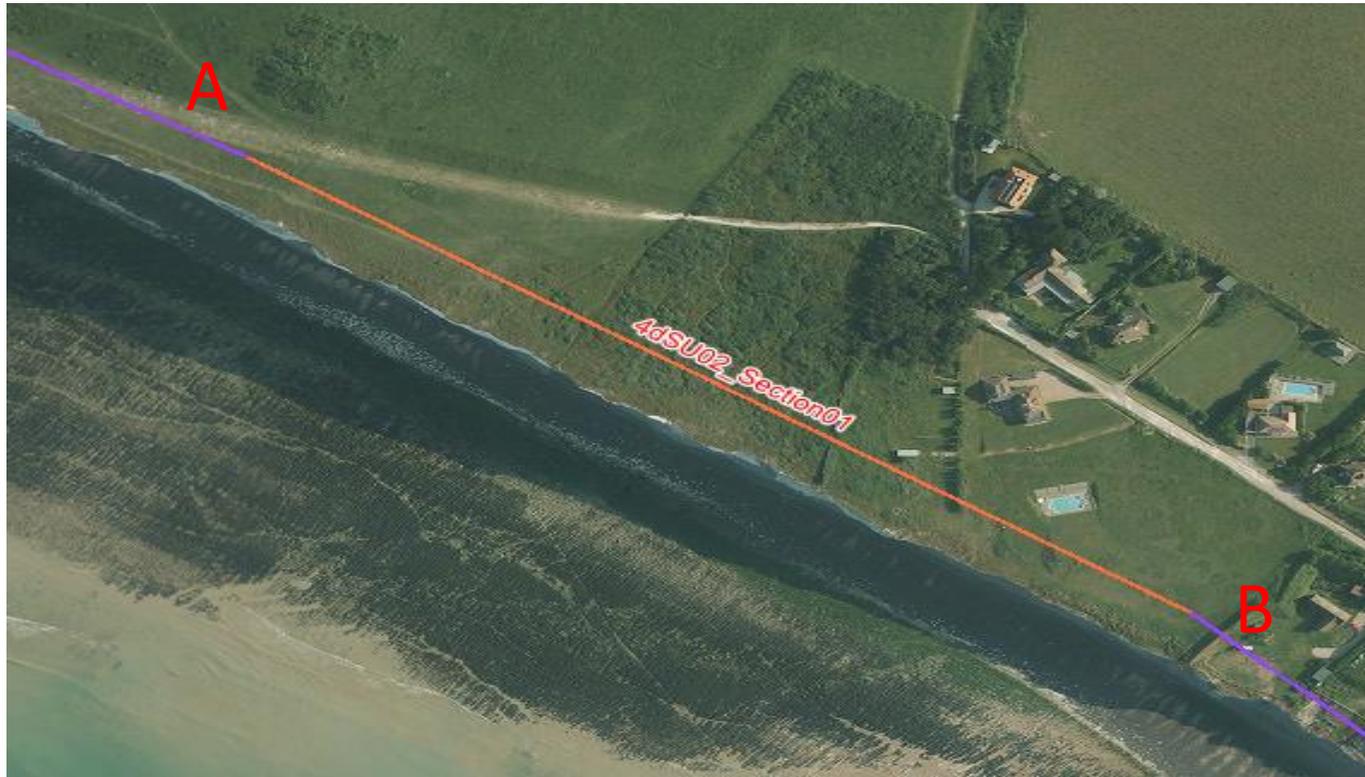
4dSU02 Section 01- Cliff Face Difference Modelling August 2015 to August 2018

The following maps show the resulting difference models of the cliff faces for each of the three cliff sections in 4dSU02. The orthorectified aerial photography used in this report is from an aerial survey undertaken in 2016. It should be noted that, as with all difference models, the changes represented should only be taken as indicative of areas potentially worthy of further investigation. Any areas of accretion or erosion on the maps require interpretation in the context of their respective locations.

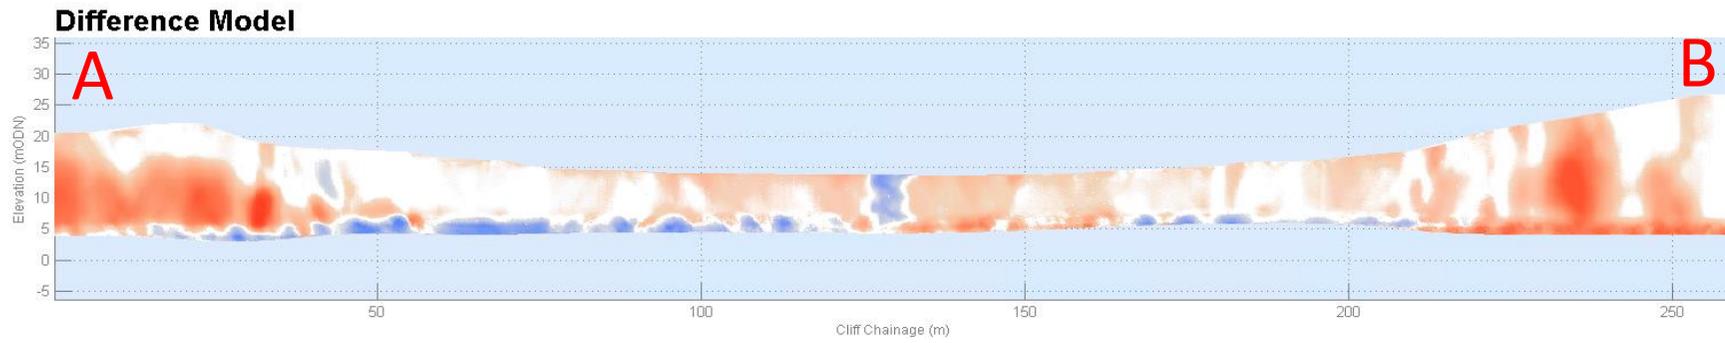
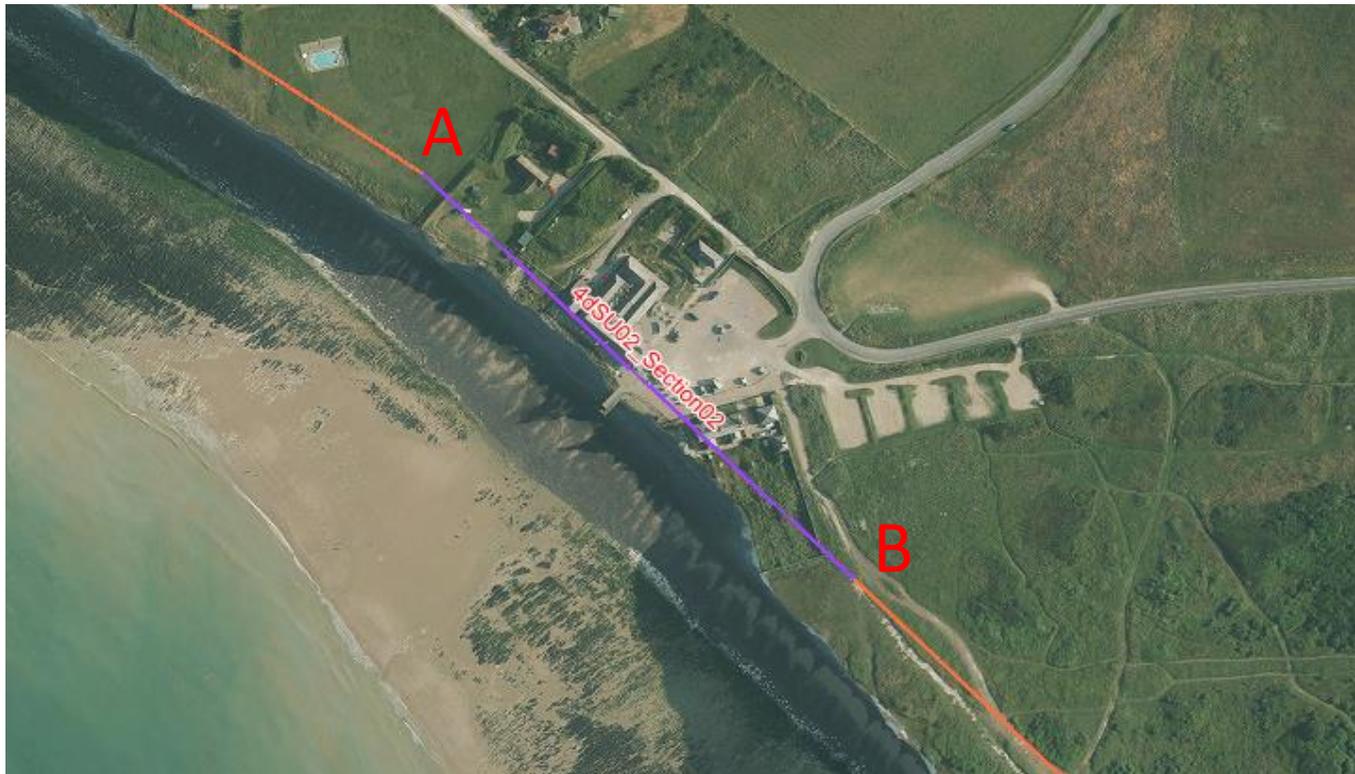
4dSU02 Section 02- Cliff Face Difference Modelling August 2015 to August 2018

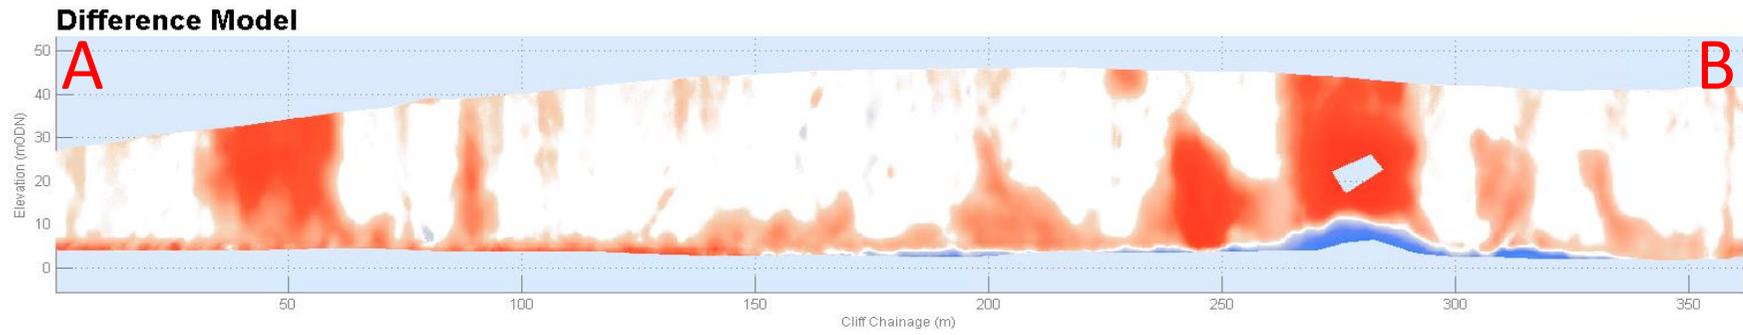
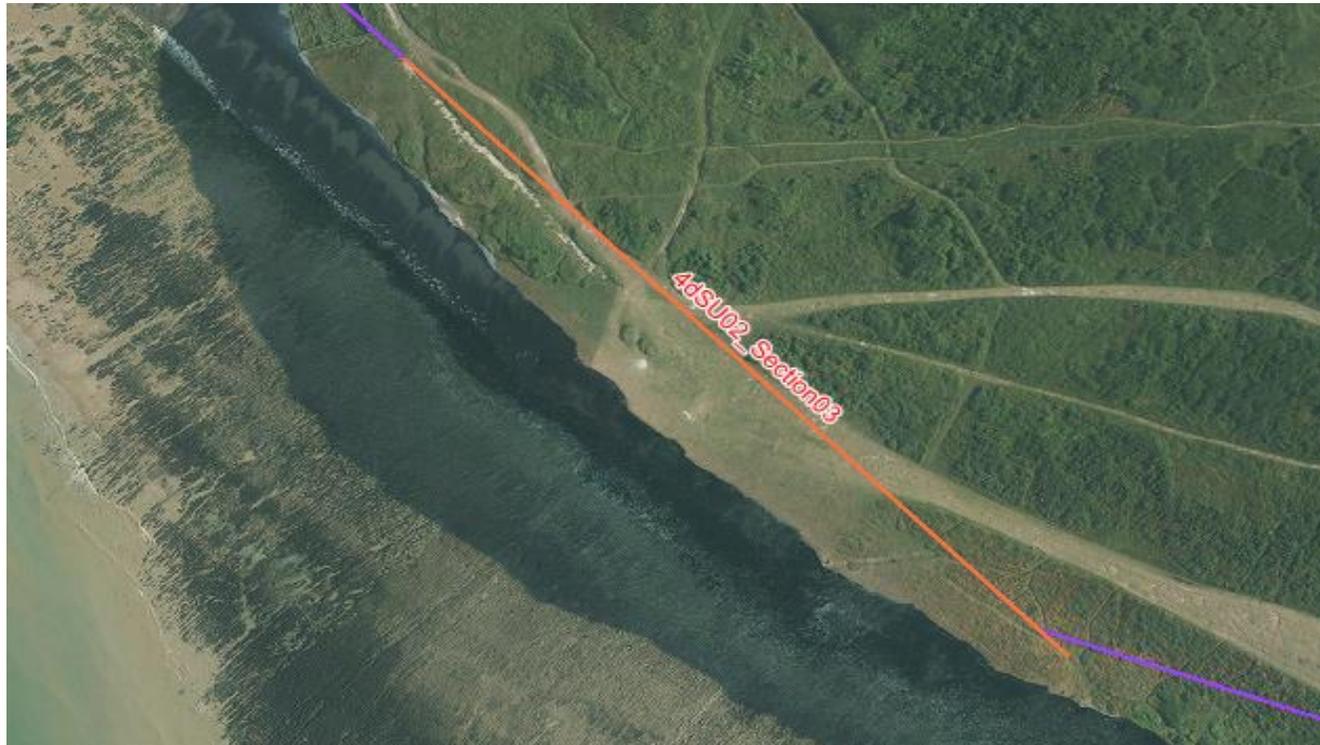
4dSU02 Section 03- Cliff Face Difference Modelling August 2015 to August 2018
