Cuckmere Haven 4dSU04- Cliff Survey Report

August 2018 to December 2018

This report covers a brief overview of cliff erosion and accretion rates of the Cuckmere Haven frontage. This area covers survey unit 4dSU04 as part of the frontages managed by Adur and Worthing Councils, as part of the Southeast Regional Coastal Monitoring Programme. The data used for this report is derived from surveys completed on the 29th of August 2018 and the 4th of December 2018.

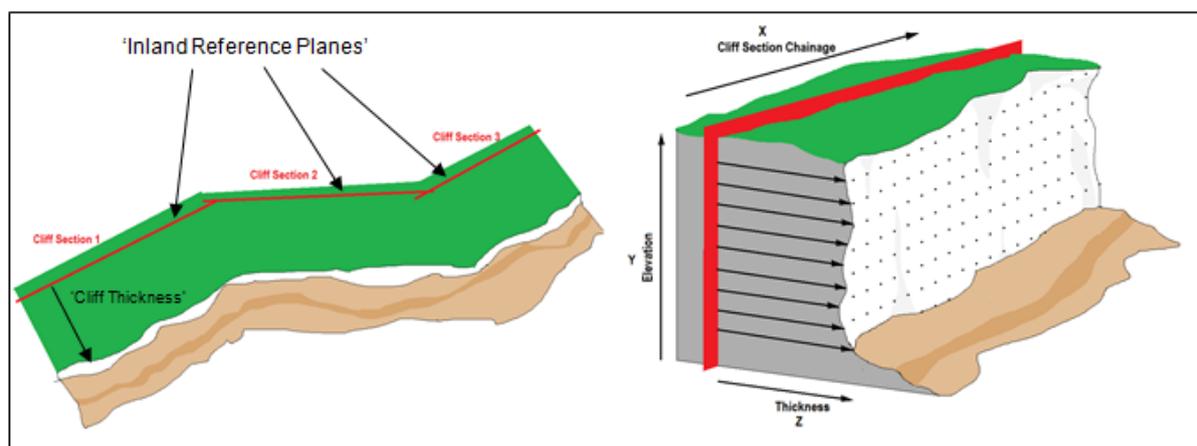
Figure 1- Inland Reference Planes and the concept of ‘cliff thickness’

Modelling of the point-cloud is achieved using inland reference planes. Inland Reference Planes have been selected simply as vertical planes that run parallel to the approximate line of the cliff face to provide a consistent comparison. This introduces the concept of ‘cliff thickness’, which is simply the orthogonal distance from the reference plane to the cliff face (Figure 1). As such, changes in cliff thickness are what are represented in the difference modelling with this methodology. The survey units are divided into sections which outline various areas, each with its own difference model. Each model shows erosion and accretion rates as colour shading, with the deepest colours showing the greater rate of change.

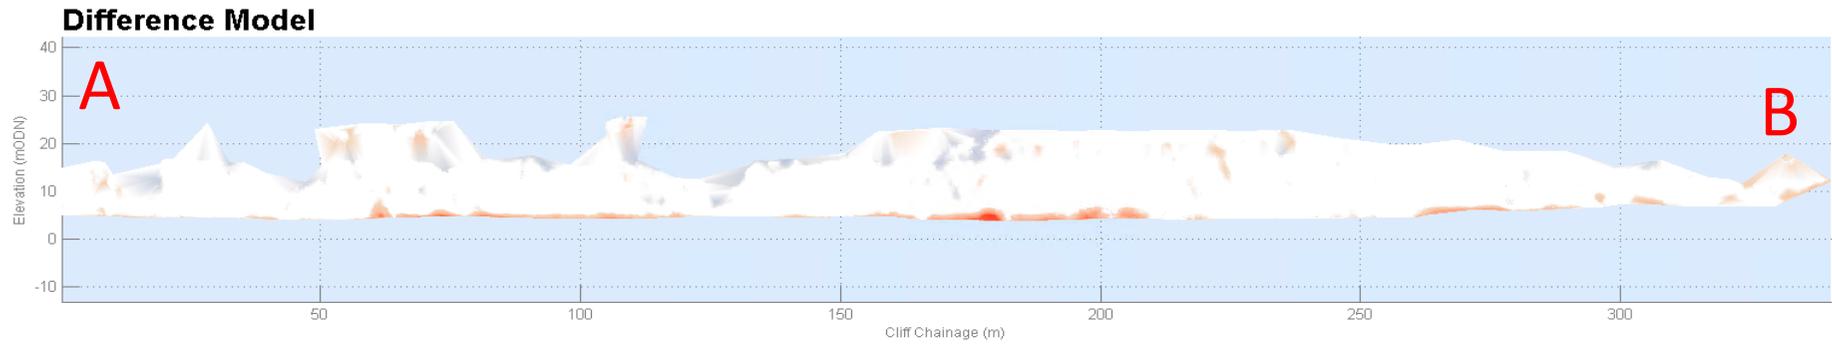
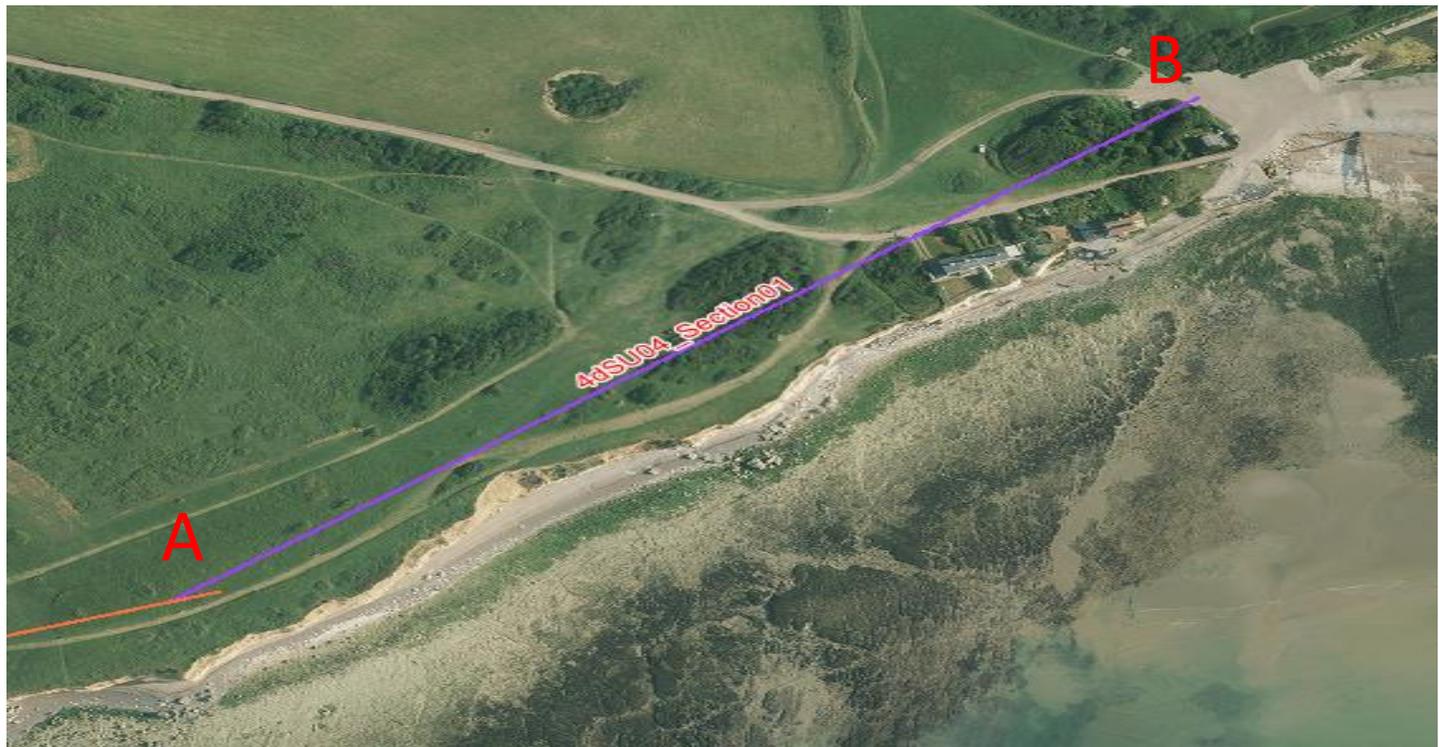
4dSU04 Section 01- Cliff Face Difference Modelling August 2018 to December 2018

The following map shows the resulting difference model for the individual cliff section in 4dSU04. The orthorectified aerial photography used in this report is from an aerial survey undertaken in 2016. It should be noted that, as with all difference models, the changes represented should only be taken as indicative of areas potentially worthy of further investigation. Any areas of accretion or erosion on the maps require interpretation in the context of their respective locations.
